GREGORY M. GRIFFITH
PROFESSIONAL ENGINEER
3552 Kirby Smith Drive
Wilmington, NC 28409-6977
(910) 791-6294

April 9, 2010

69 & 70 Cougar & Mustang Clutch & Brake Pedal Bracket Removal & Replacement

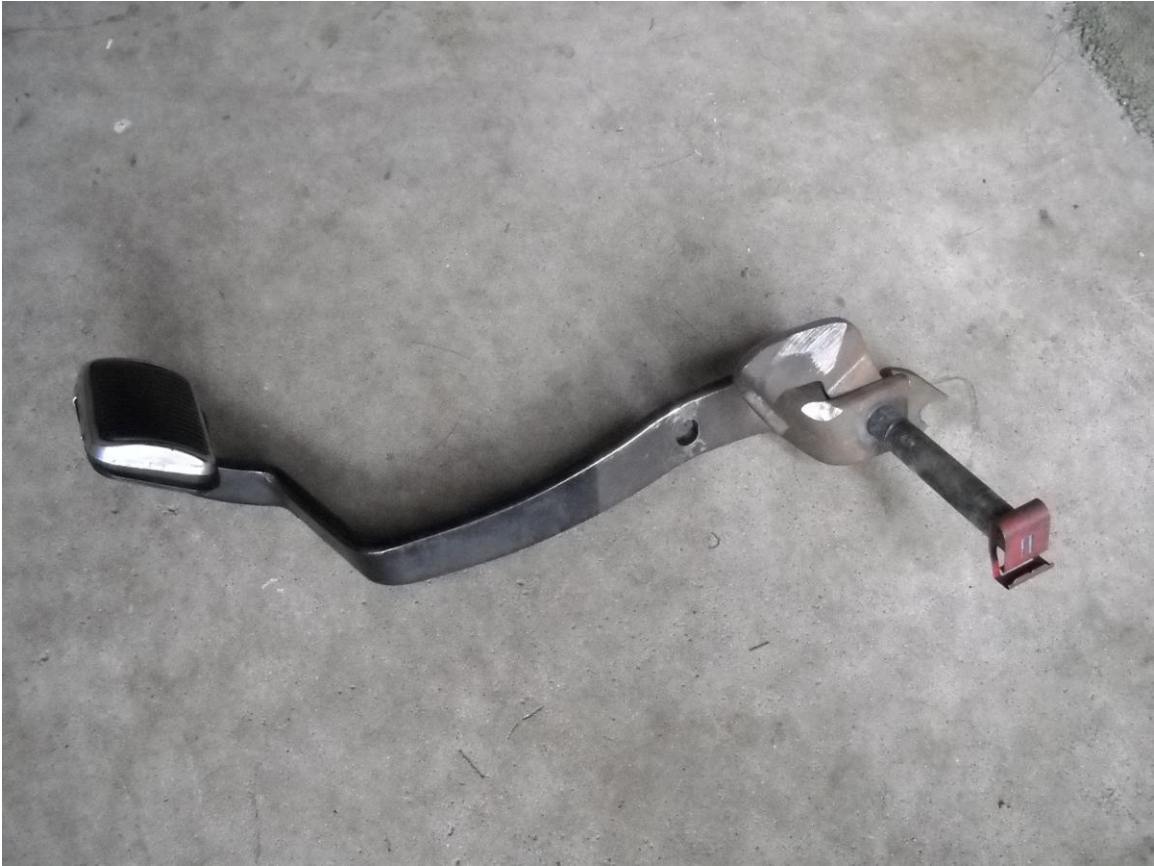
Original clutch pedal. Note cut in pedal shaft near pedal where pedal bracket wore into shaft and oval shaped rod hole necessitating pedal repair or replacement. Wear on pedal was the result of pedal play from worn pedal bearing and shaft.

The clutch pedal mounting shaft was severely worn and the rod hole was a big oval. The pedal was replaced with a new reproduction that used a stainless mounting bolt in lieu of the pressed in shaft on the original. The worn bushing hole in the bracket was welded and machined back to original dimensions. The friction bushings were replaced with a Scott Drake ball bearing kit. Since the bearing holes in the bracket are flat sided top and bottom to stabilize the zinc friction bearings, the ball bearing mounting washers were spot welded to the bracket to keep the bearing from sliding back and forth under load. Use the clutch mounting shaft to keep the bearings aligned during the spot welding operation. I spent about \$320 in new parts and labor for refurbishing the bracket, replacing the clutch pedal, master cylinder, all the bushings in the clutch linkage and new clutch and brake pedal pads and trim. Your cost may vary depending on what parts need to be replaced or repaired. Fix or renew everything while you have access and you will be rewarded with a smooth, like factory new clutch operation and appearance.

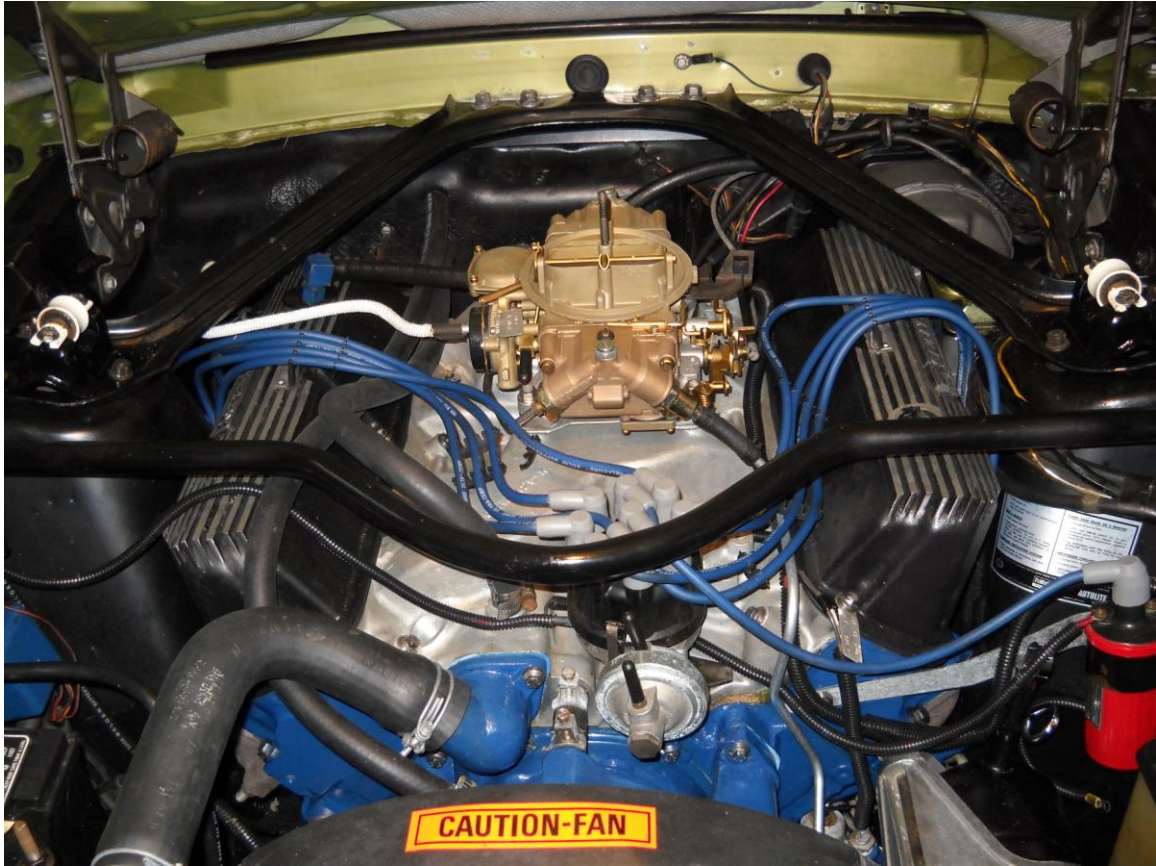
Engine compartment showing Export brace and Monte Carlo bar that must be removed to remove driver side valve cover for brake booster removal. Note torque strap bolted to driver's side cylinder head and fender well and relocated coil to reduce coil heating. Aluminum manifold is a 427 K-code medium riser port matched to the 428CJ heads. Carburetor is a numbers correct 735 CFM Holley.

2. Engine Bay Preparation. The driver's side valve cover must come off to remove the power brake booster from big block cars and possibly from 351 powered cars. My car has an export brace and a Monte Carlo bar that must be removed to remove the Shelby style high rise valve covers. On most big block cars, the driver's side shock tower brace may need to be removed to facilitate the valve cover removal depending on the cover style.

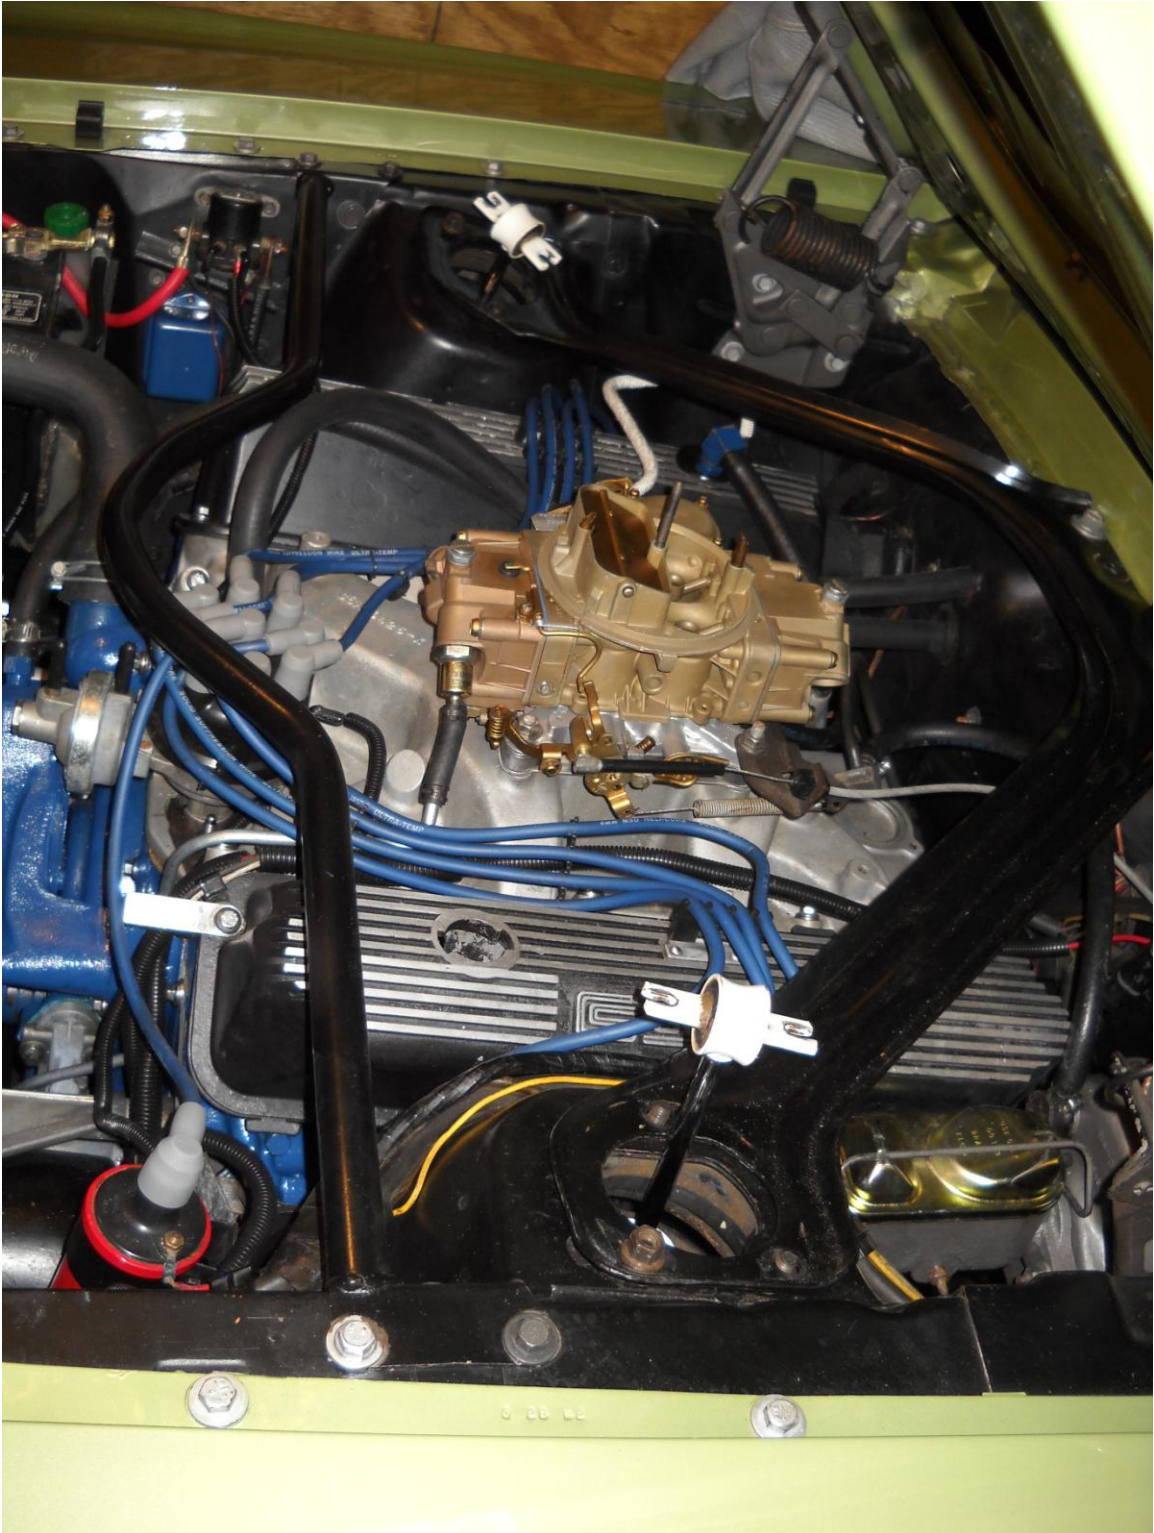
Shock supports Removed.

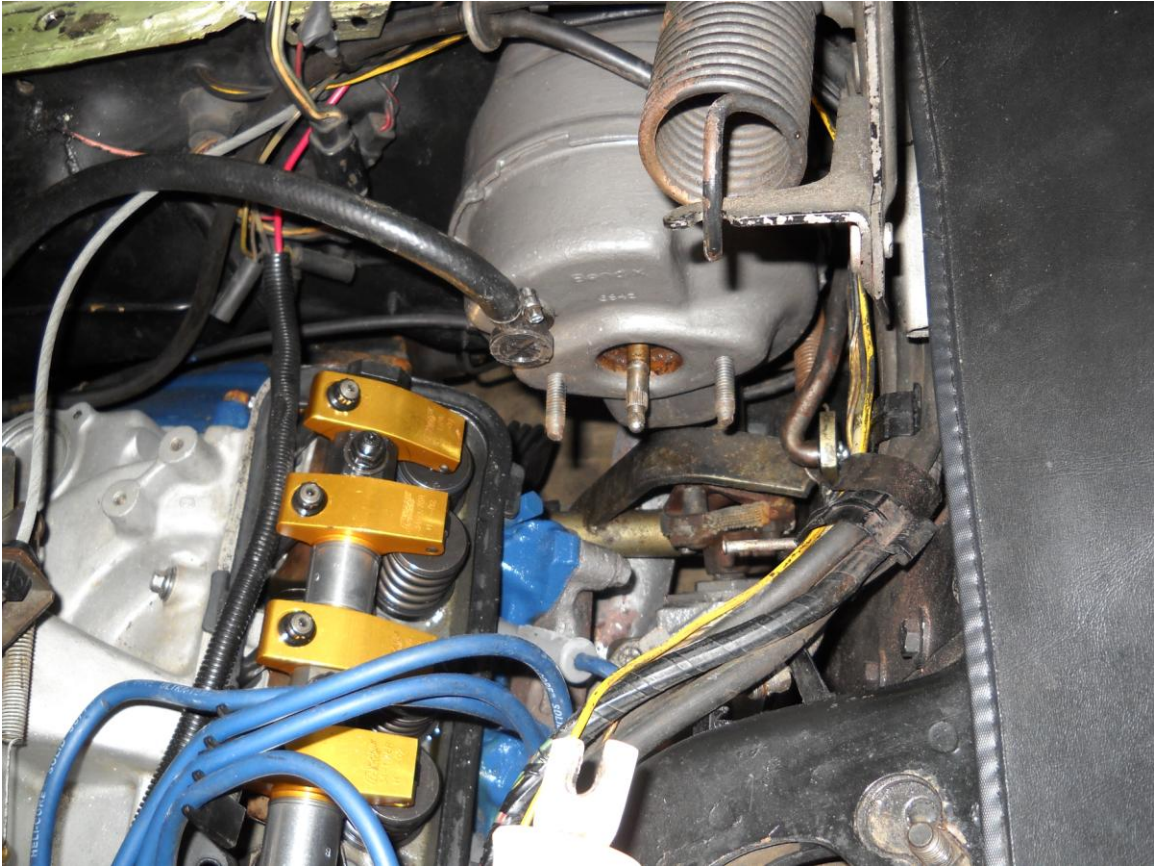
Export Brace, Monte Carlo Bar, Valve Cover and Brake Master Cylinder removed. Steering column to steering box attaching nuts exposed just below top of Z-bar. The retaining pin for the through the dash rod is now easy to access.

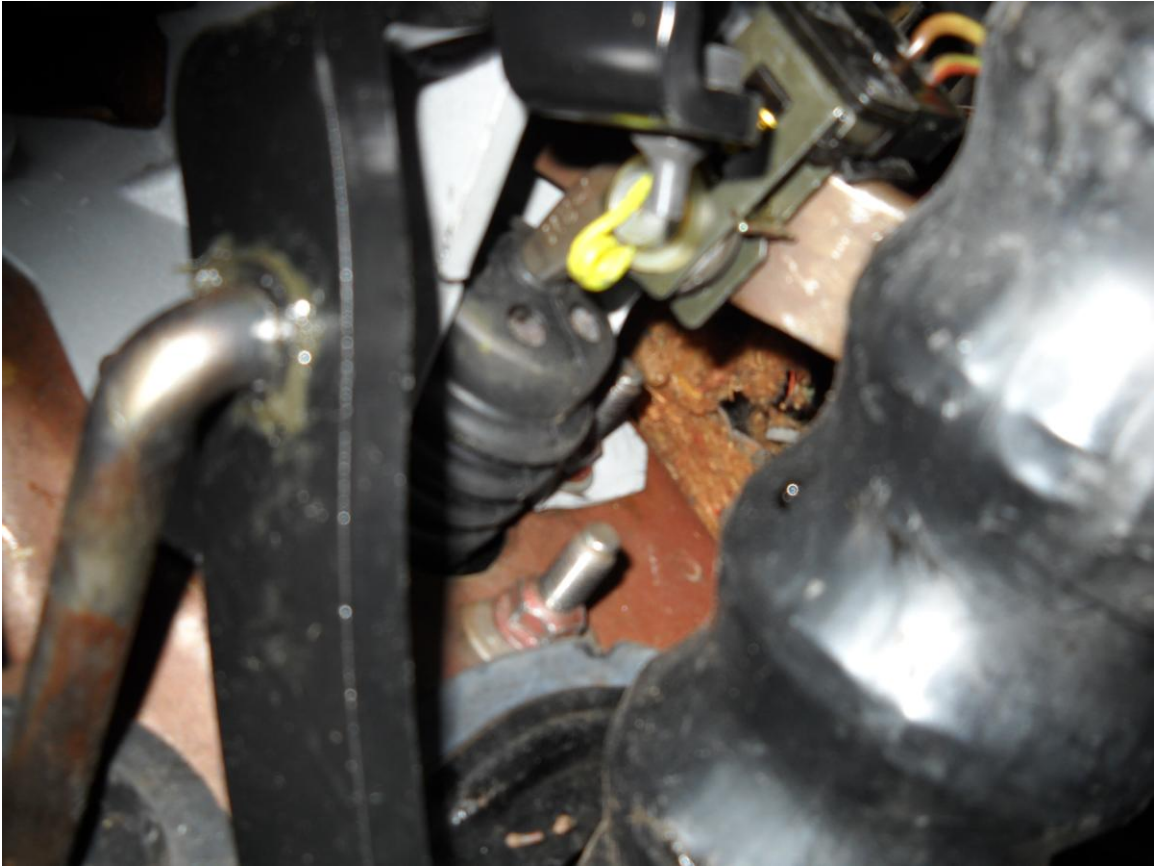
Clutch pedal (foreground), brake pedal showing clip holding booster rod and brake light switch. The clip is removed to remove the rod and switch from the brake pedal. Easier to perform after steering column is out. Note cramped quarters with steering column in place.

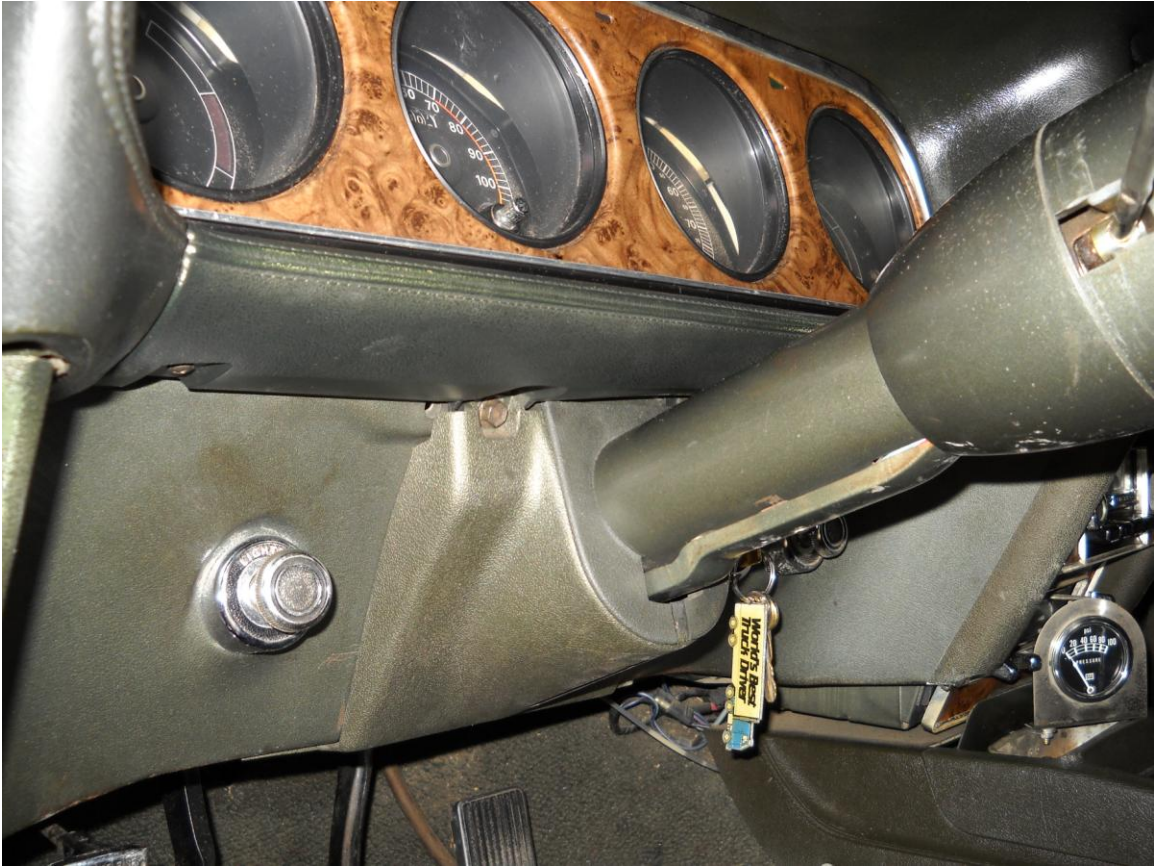
Plastic trim around steering column and lower dash trim just above steering column must be removed to facilitate dash and steering column removal.

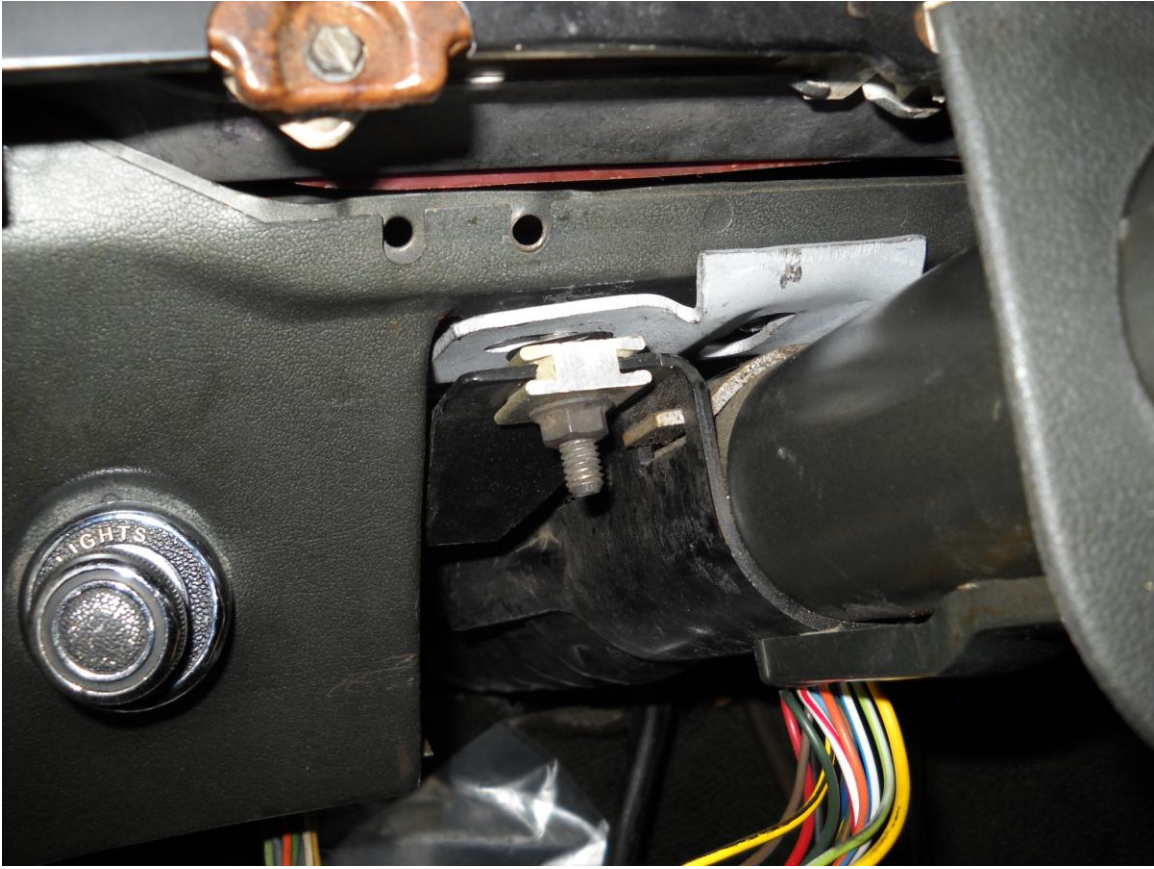
Steering column mounting studs are located behind plastic trim piece. Remove stud nut on each side of the column.

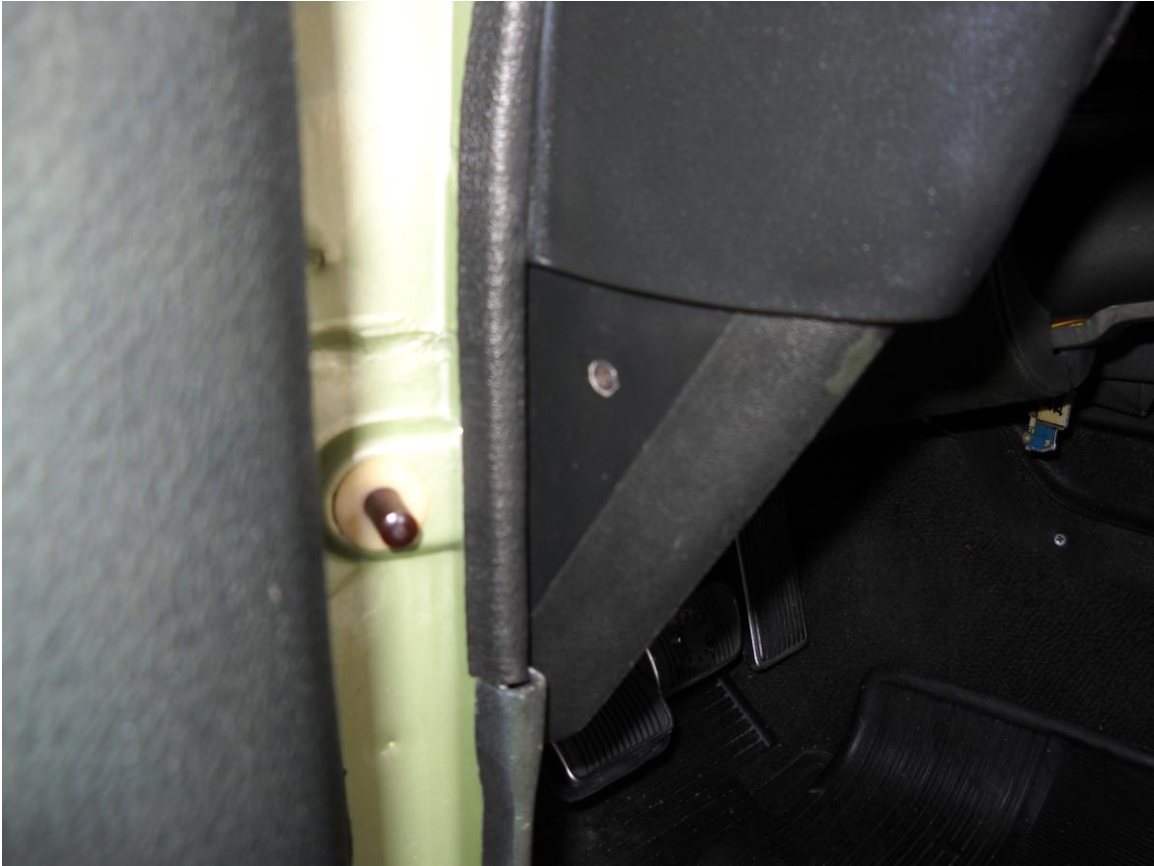
Lower dash trim (driver's side) showing attaching screw that requires short Philips head screw driver to remove.

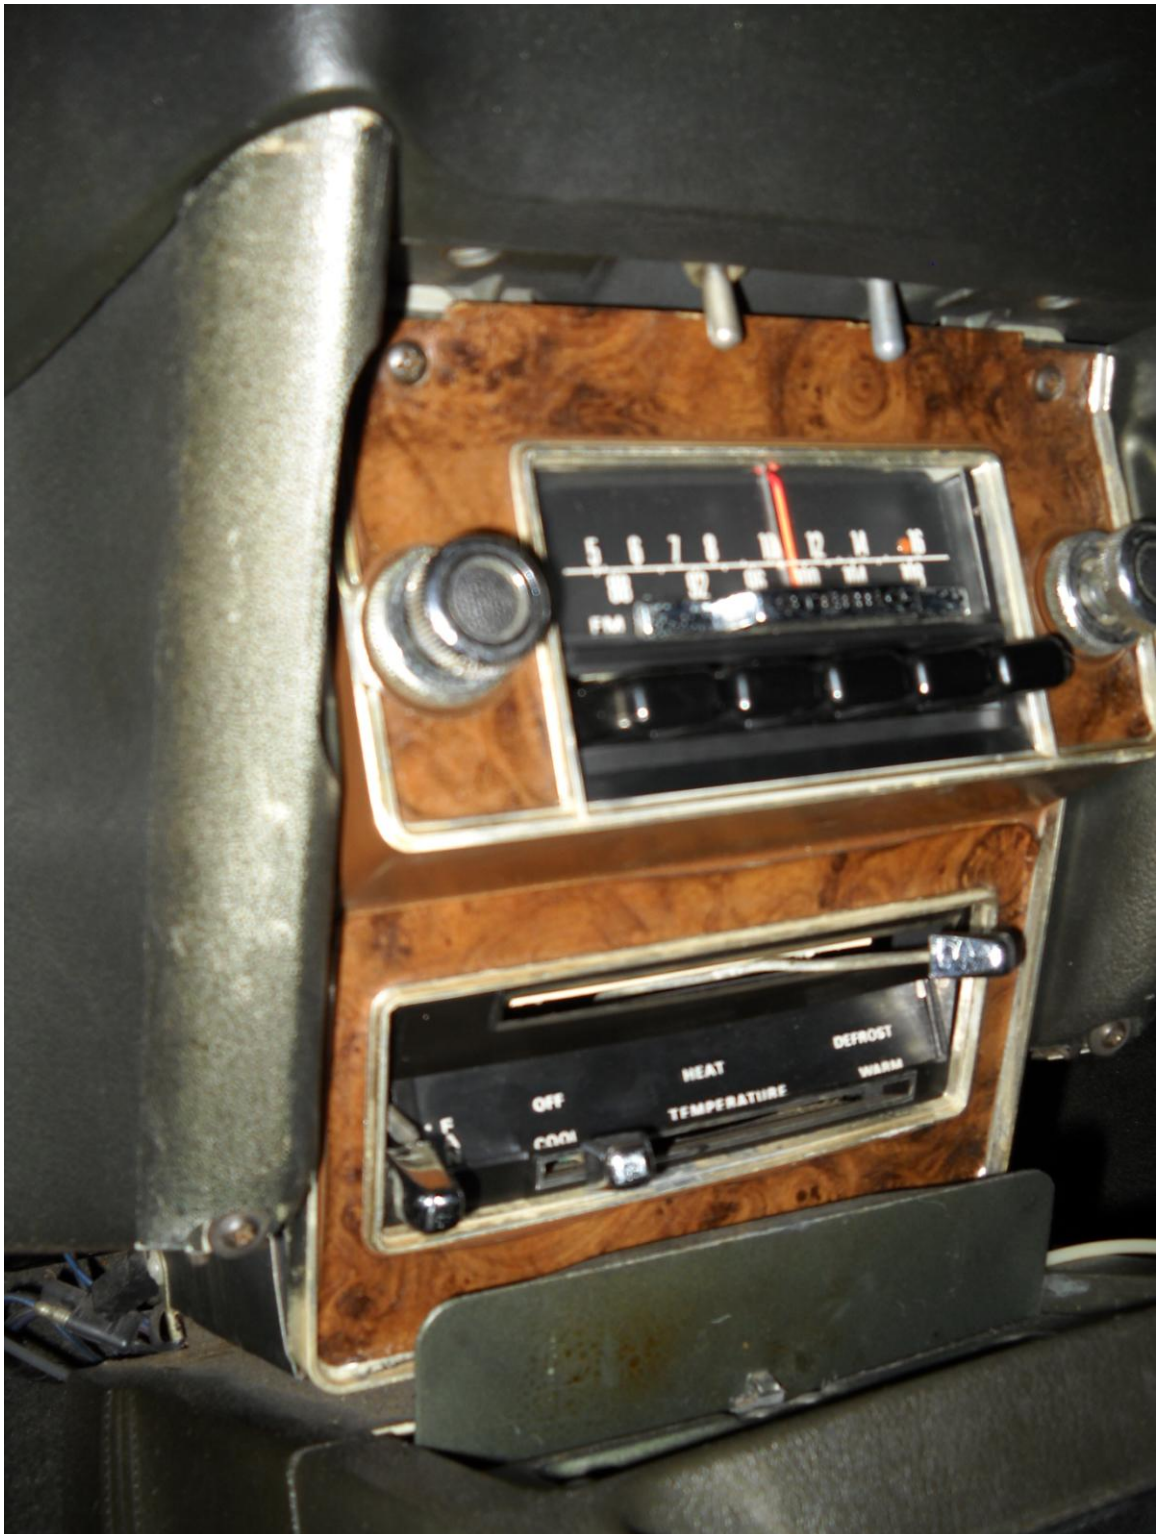
Radio/heater trim panel that must be removed to access trim and dash attaching screws.
Note two Philips head screws at top of trim piece.

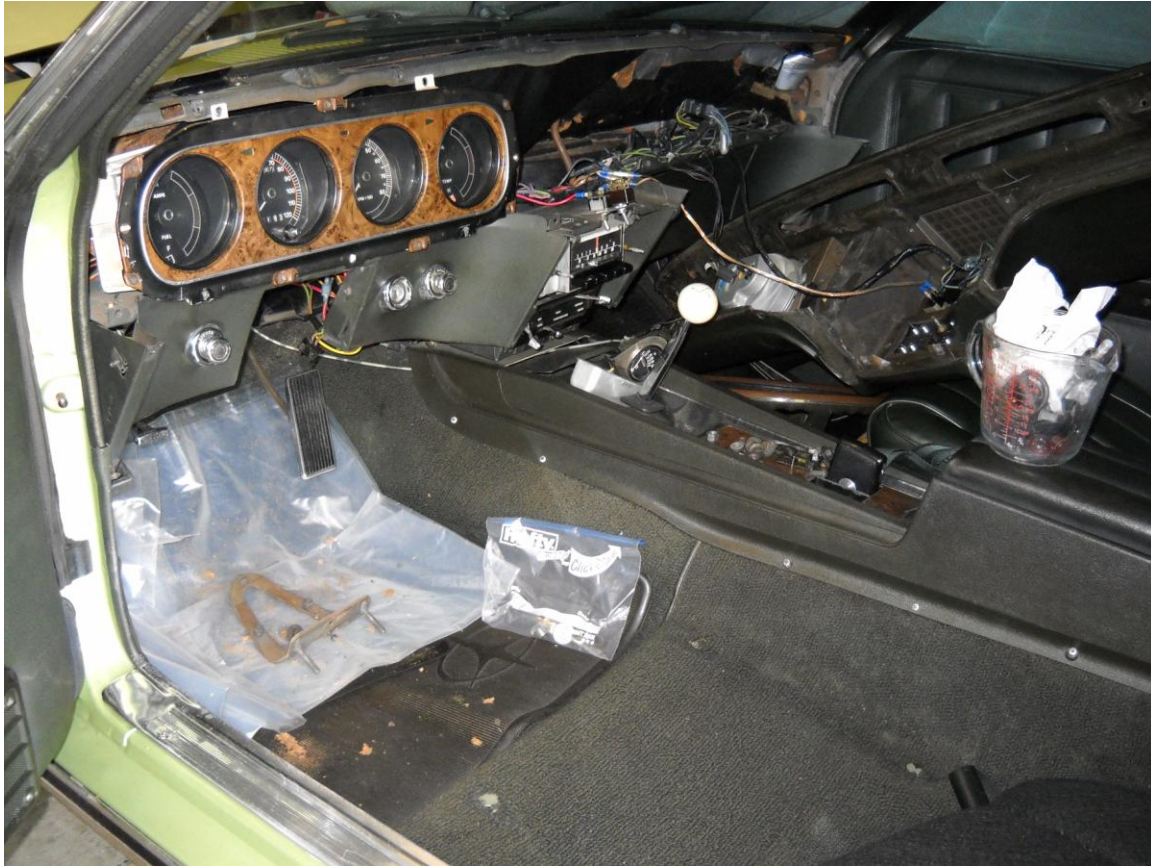
Interior with driver's seat, steering column, dash pad removed. Note plastic liner to protect carpet. The bracket on the floor mounts behind the instrument panel to the dash structure and provides anchorage for the steering column mounting studs seen in the bracket. Brake booster studs are now easily accessible through steering column and instrument cluster voids.

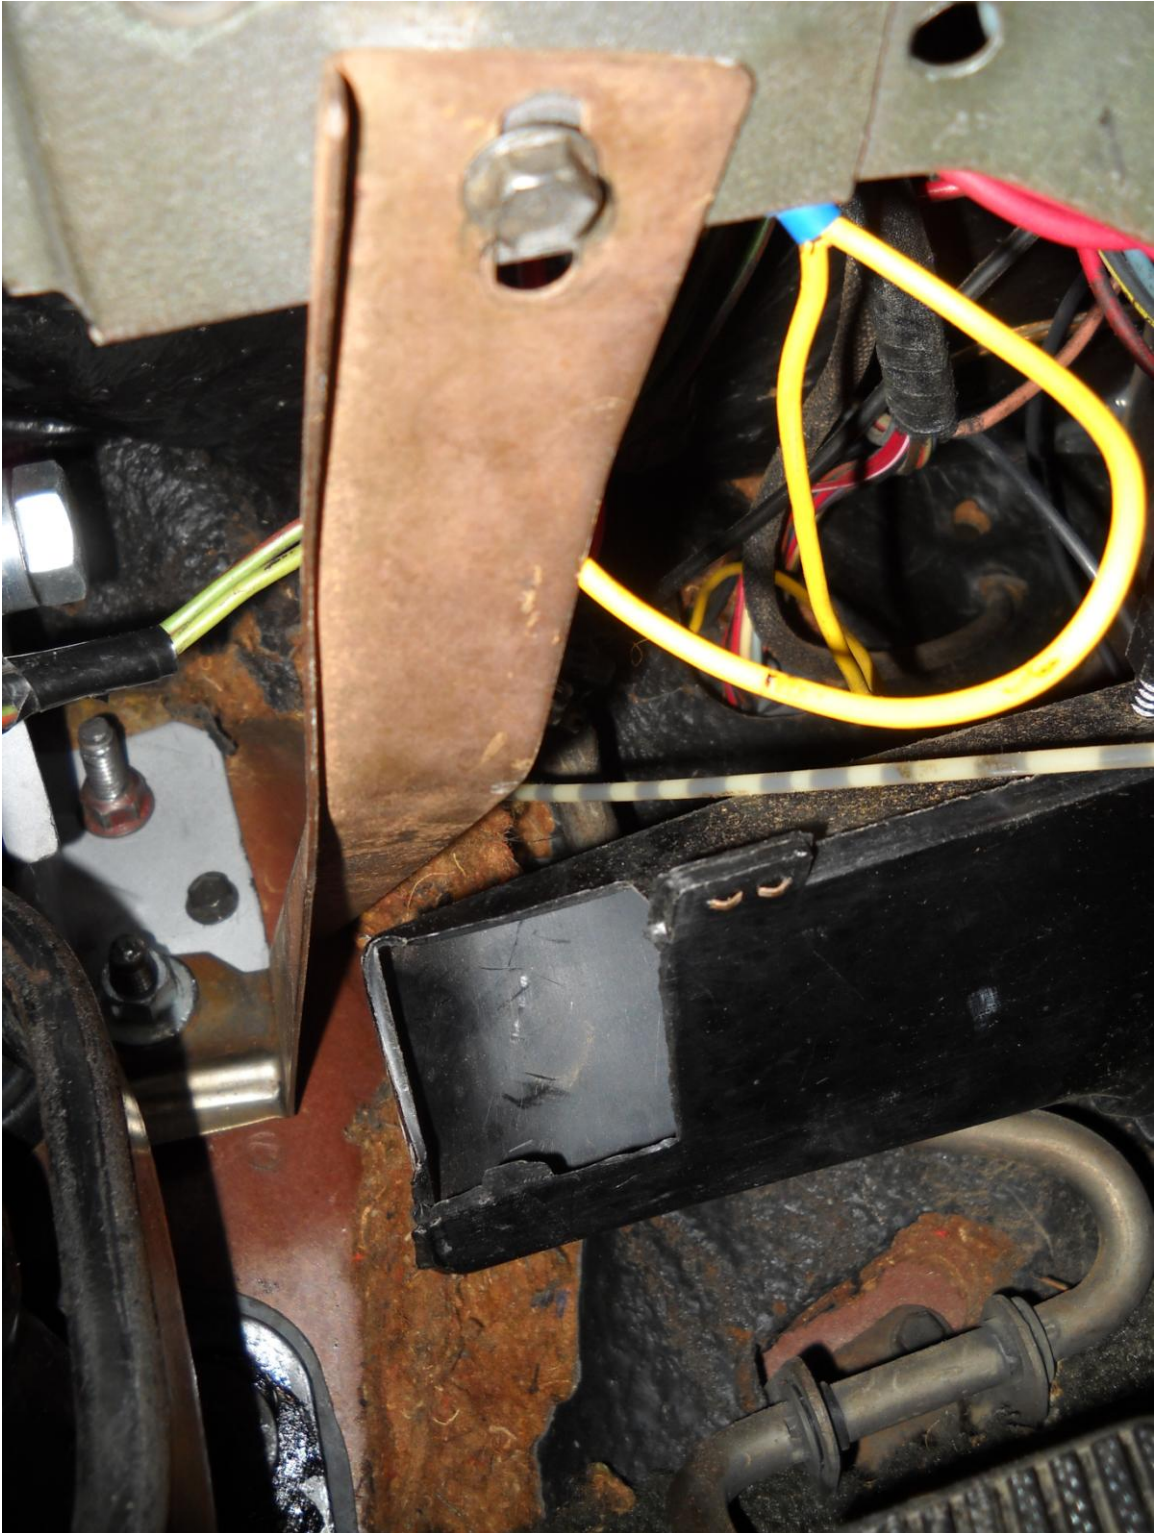
Under dash brace that must be removed with power brake booster stud nut.

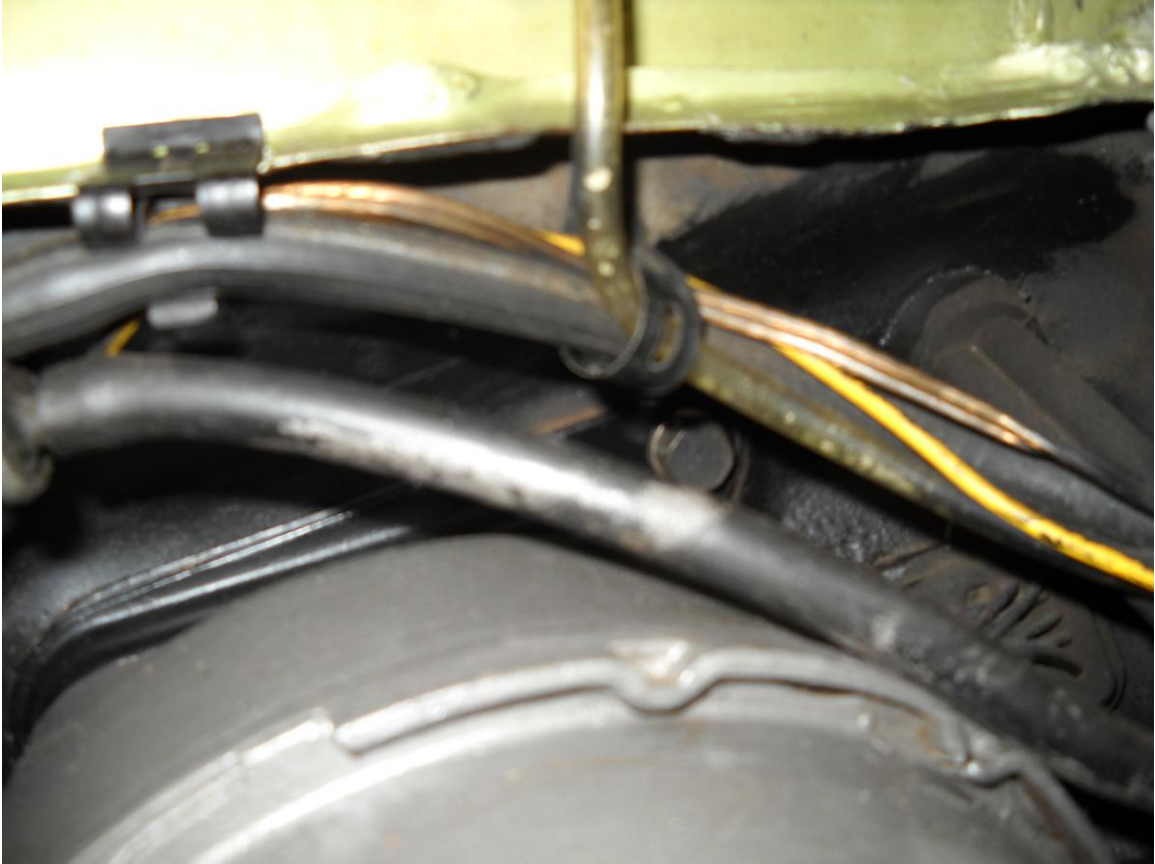
Power brake booster mounting bolt in the engine compartment. Remove this bolt with a 9/16-inch socket and extension.

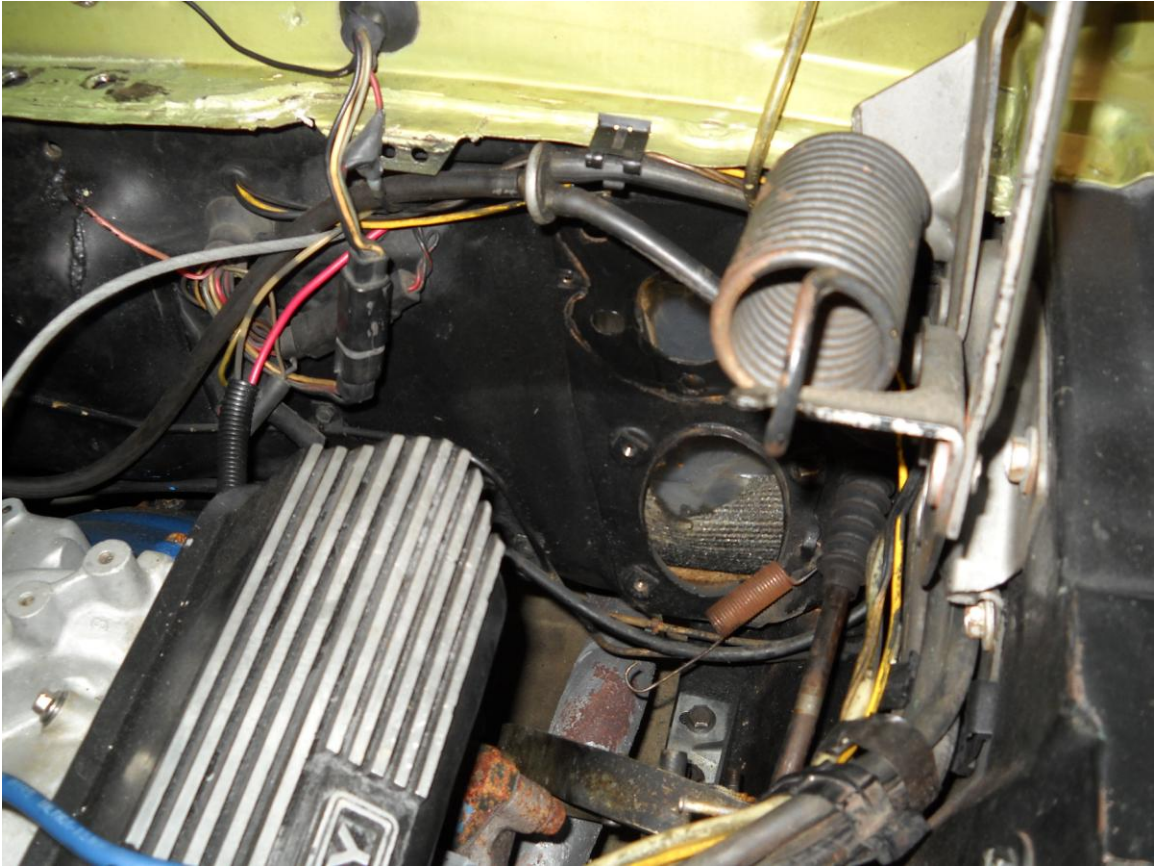
Engine compartment with master cylinder and power brake booster removed. Note Z-bar frame bushing mount bolts are easily accessible.

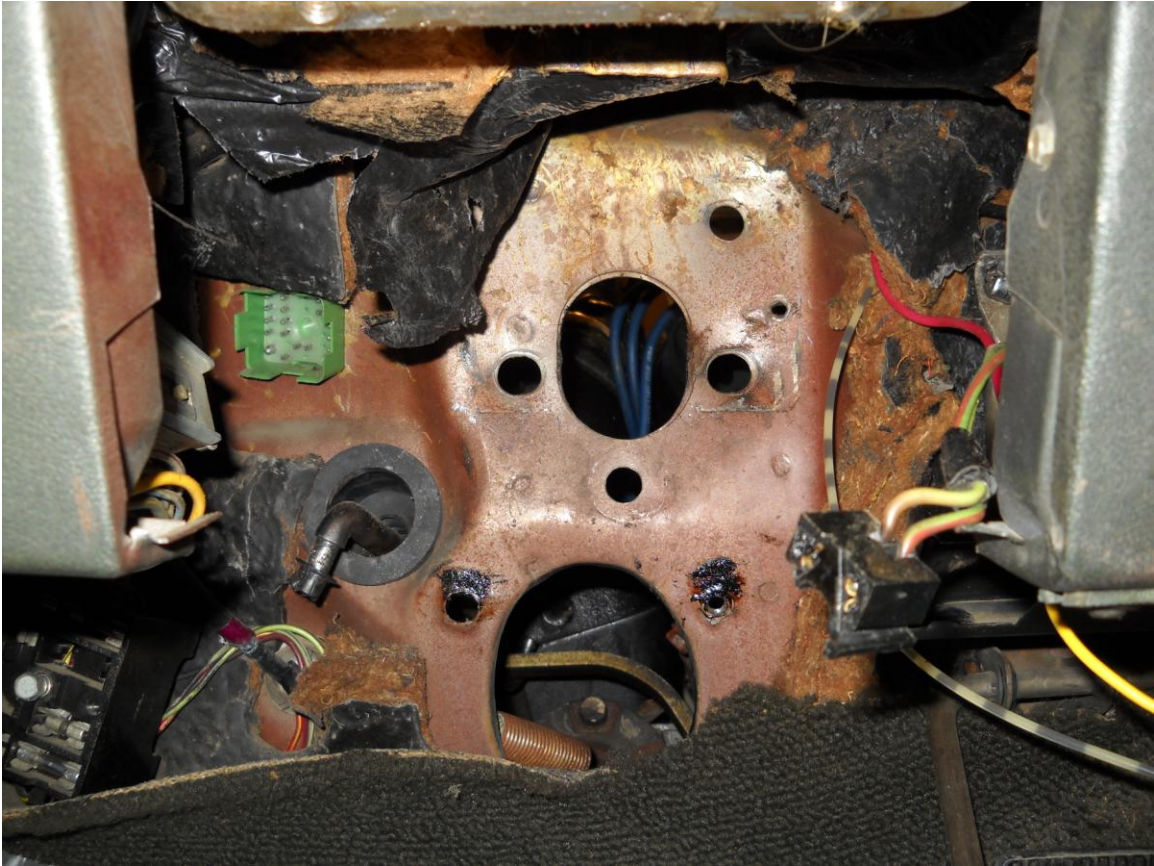
Brake booster and steering column holes through fire wall after pedal bracket removal. Some insulation repair is needed before reassembly. Fuse box was removed from firewall to avoid damaging it. This does not need to be done if the steering column is out.

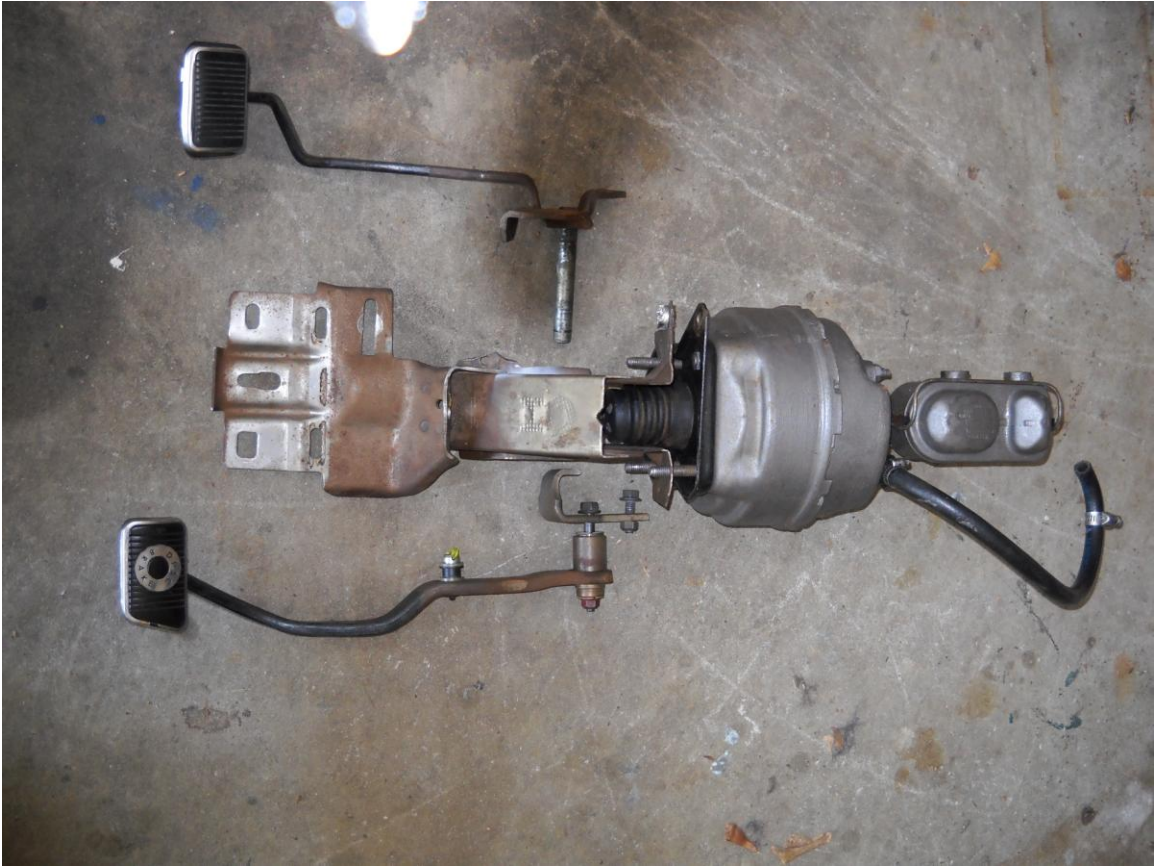
The pedal bracket, brake and clutch pedals, brake booster and master cylinder after removal from the car.
